Flying the *Friendship*

A former airUK pilot recalls the pleasures and pitfalls of flying the F.27 – a fantastic aircraft that taught him his trade

Feature: Flying the Fokker F.27 Friendship

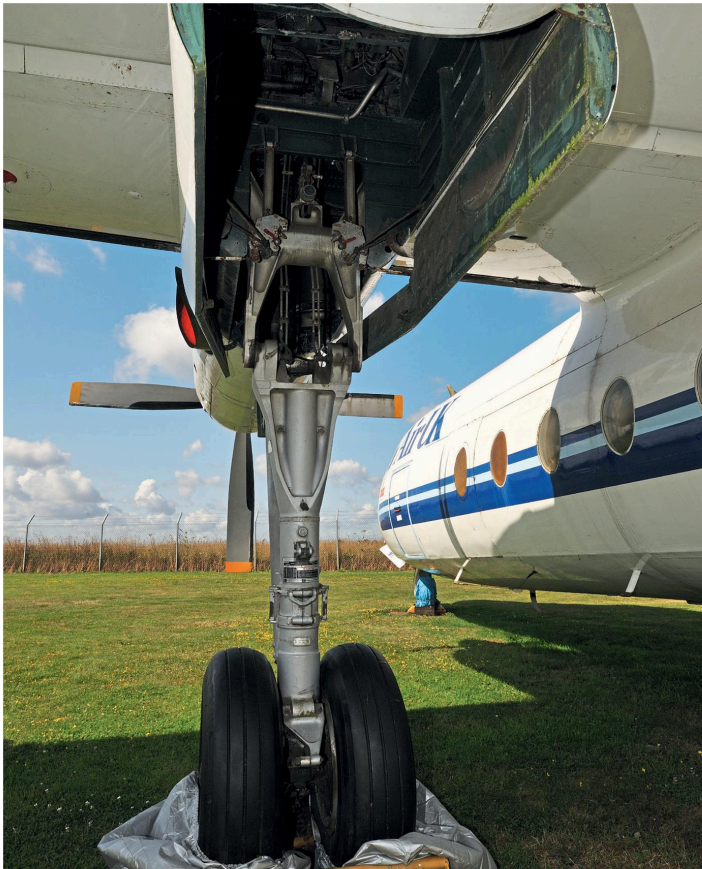
▲ Seen here on surviving airUK F.27-200 Friendship G-BHMY, the port main undercarriage leg and doors
 ▶ Preserved at the City of Norwich aviation museum and 'looking for all the world as if it's ready to go out on its next service', MY's cockpit

on board. With a hiss, the pneumatics extend the gear – it takes up to fifteen seconds. *Clonk, clonk...* and that’s it. The port main gear has not extended.

With its high wing design, the F.27's gear can be seen from the passenger cabin so the engineer is despatched to see what's going on. He soon comes back with a white face, "it's jammed up against the undercarriage doors". For me, if it had to happen the circumstances couldn't have been any better – no passengers or cabin crew to worry about, and a crosswind from the right at base, so I can yaw it to the left, plant the starboard main gear down and hold the port side up till the very last minute. Also, we are not fat with fuel.

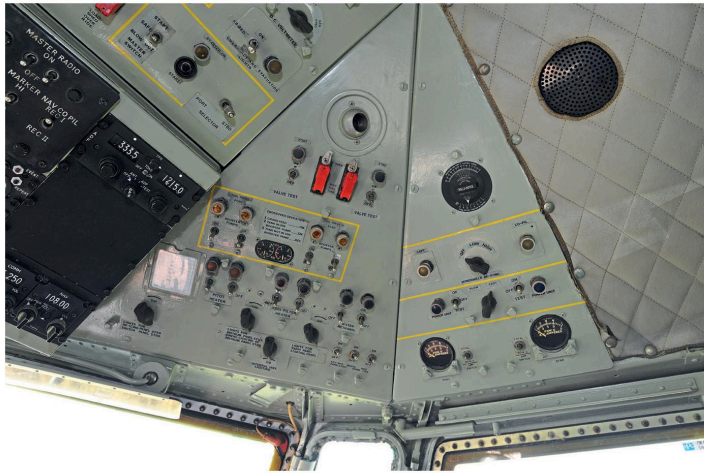
Overhead panels in what was otherwise a very WWI-era cockpit include the engine start switches

Starting was simple and once the start button was pressed, he process was automatic. Two 'fuel trim' switches were located on the right hand side of the centre console, with their associated datum dials directly above them. These were to control the fuel flow at different ambient temperatures and pressure altitudes. A setting computer was positioned on the starboard overhead panel. Since we didn't operate from high airports or in extreme temperatures, I can't remember ever using it. We just pressed the start button, opening the high pressure fuel cocks at 1,200-1,500 rpm and watched for the rate of rise of the turbine gas temperature. If it was rapidly increasing toward the maximum of 930°C we would use the fuel trimmer to reduce the fuel flow to keep it within limits. If that wasn't enough, we would 'milk' the fuel cock to achieve the

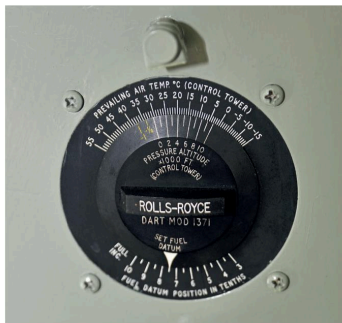
Located in the extreme right quadrant of the overhead panel, the mechanical fuel flow calculator never used in airUK ops

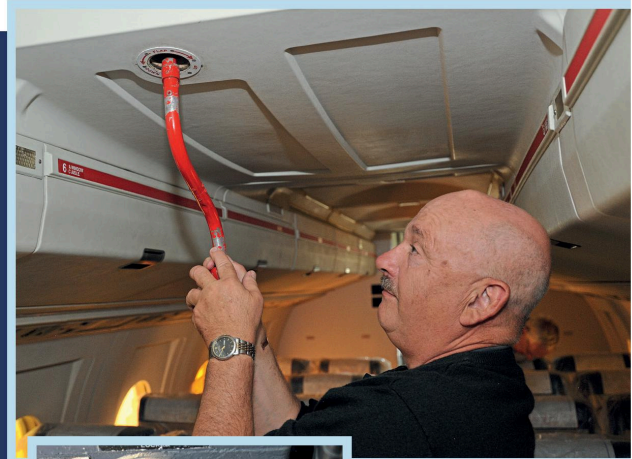
Matt Taylor demonstrates the manual flap extension crank

Large, electrically-controlled fowler flaps had the following settings: 0, 11.5, 16.5, 26.5 and 40 degrees. Takeoff was 0° or 16.5°, cruise 0°, approach 16.5° then 26.5°, and landing 40°. We never used the 11.5° setting and, in fact, never found out what it was there for! The flaps could be manually extended by de-pressurising, pulling the circuit breakers on the flap control and brake, and going into the passenger cabin with a crank handle, removing a plug between the wings, and winding away.

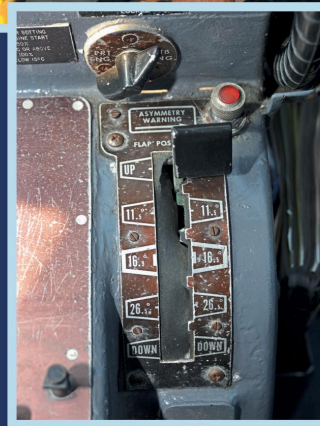
Multiple settings for the flap lever include a curious 11.5° never used
